Photo 1: Overview of the rear of the Facility. Taken 5/26/15.

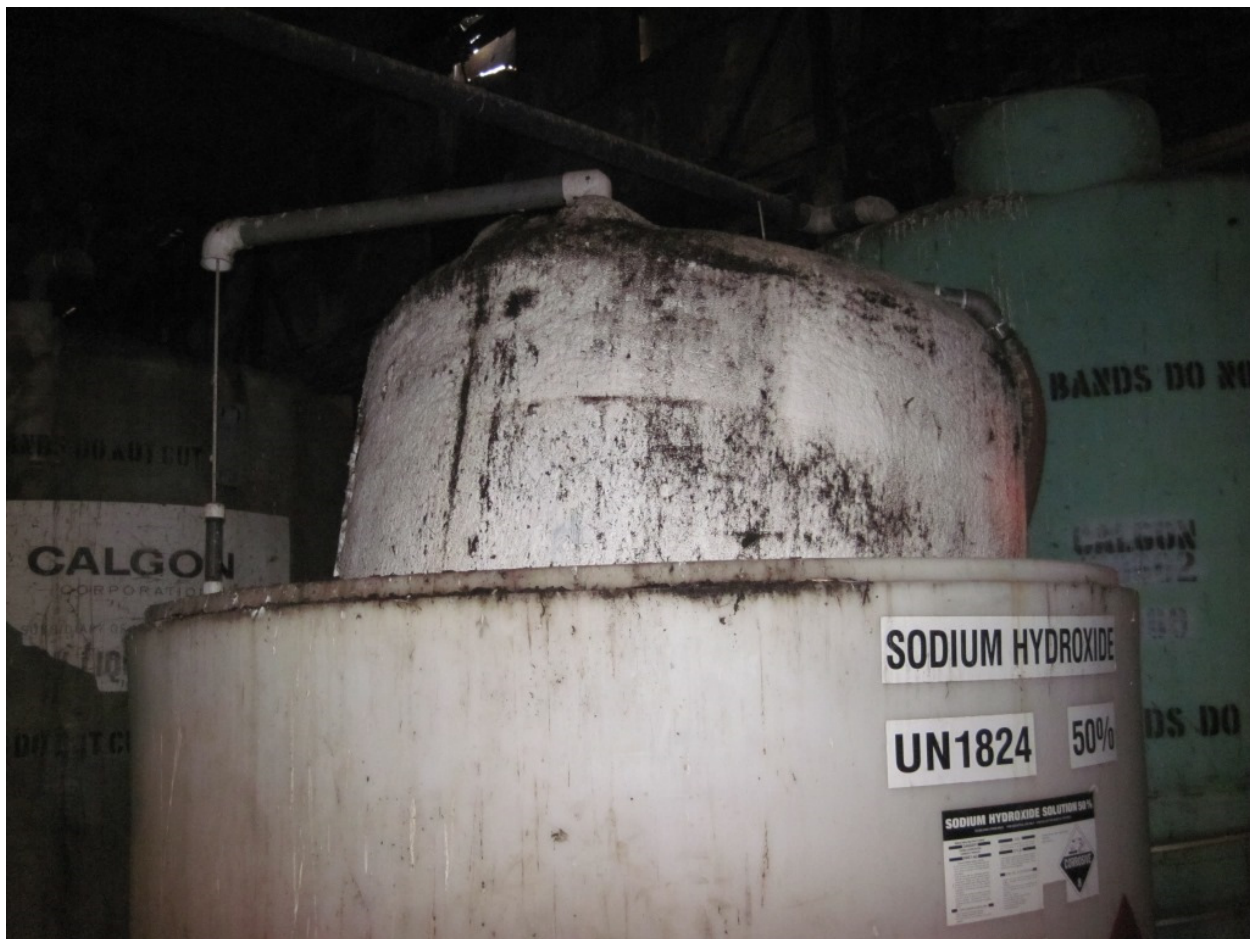
Photo 36: Overview of a WWTU tank labeled as Sodium Hydroxide. The sodium hydroxide had solidified at the time of the inspection, and was observed at the top of the tank.

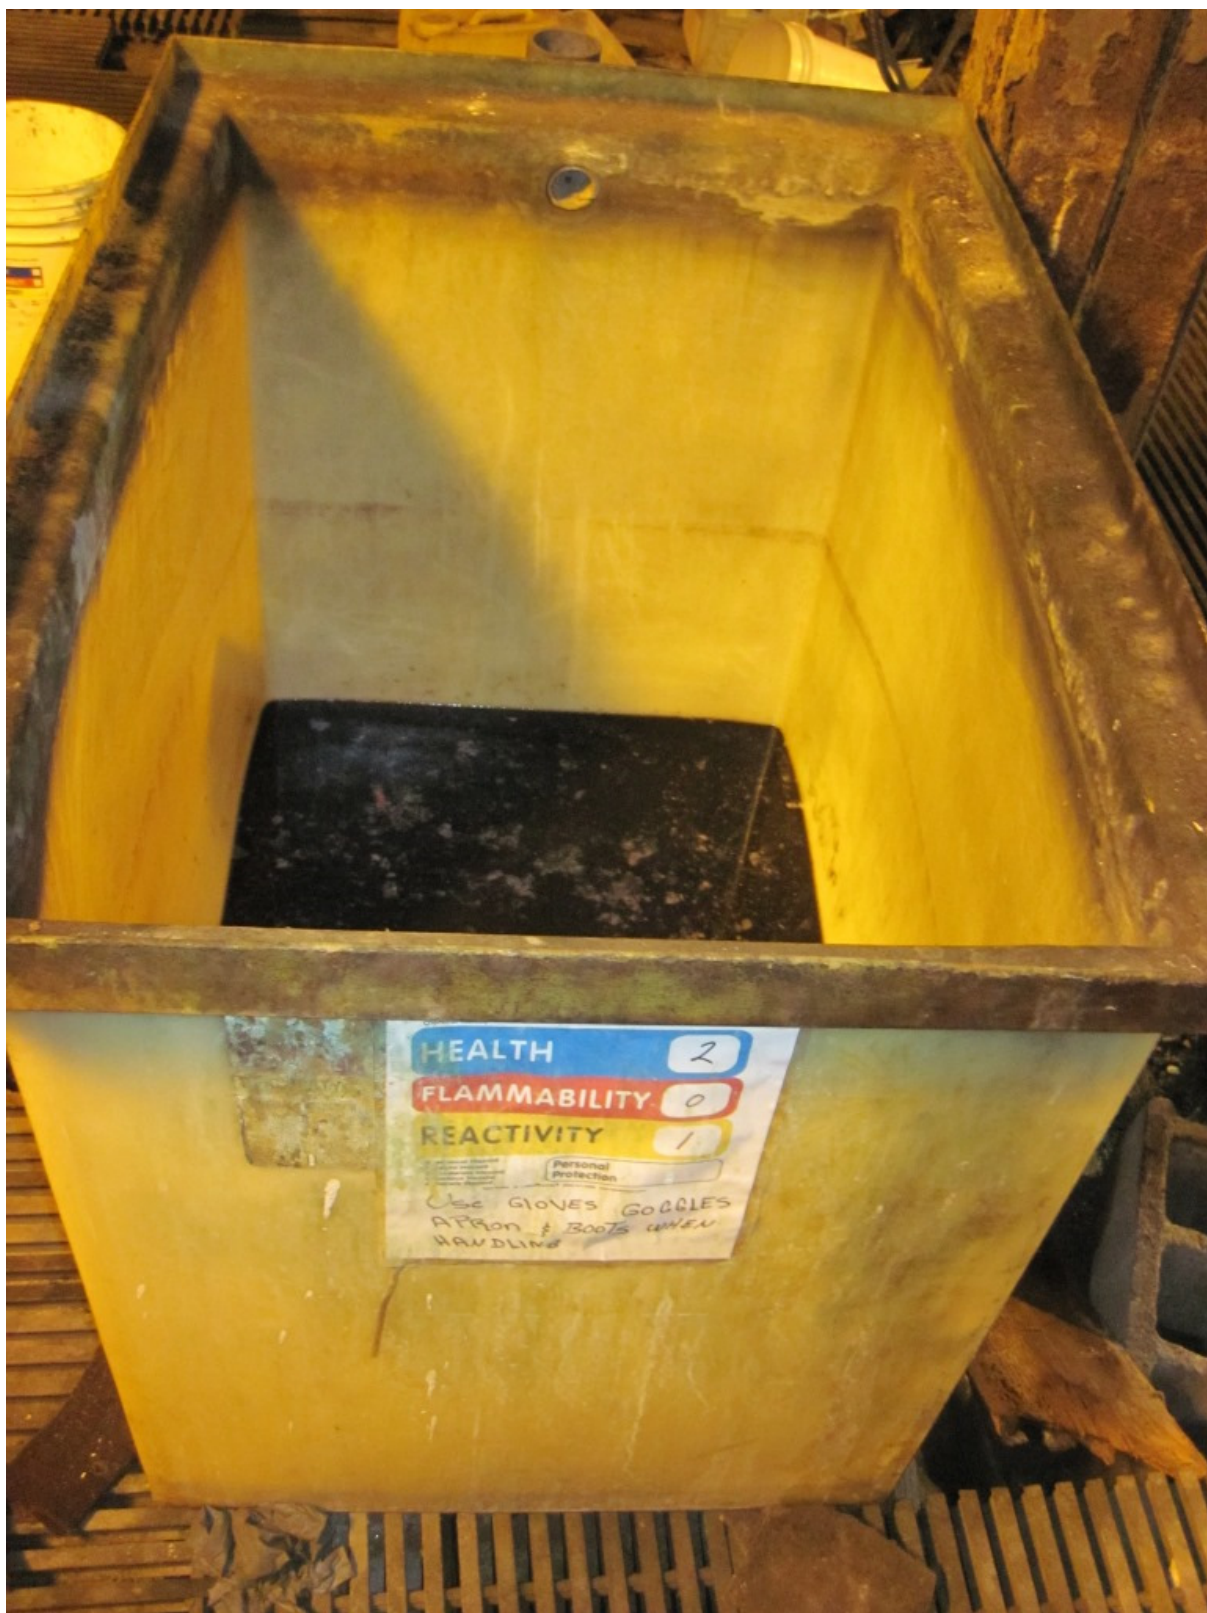
Photo 37: Overview of a process tank with an unknown liquid in the electroless nickel plating line.

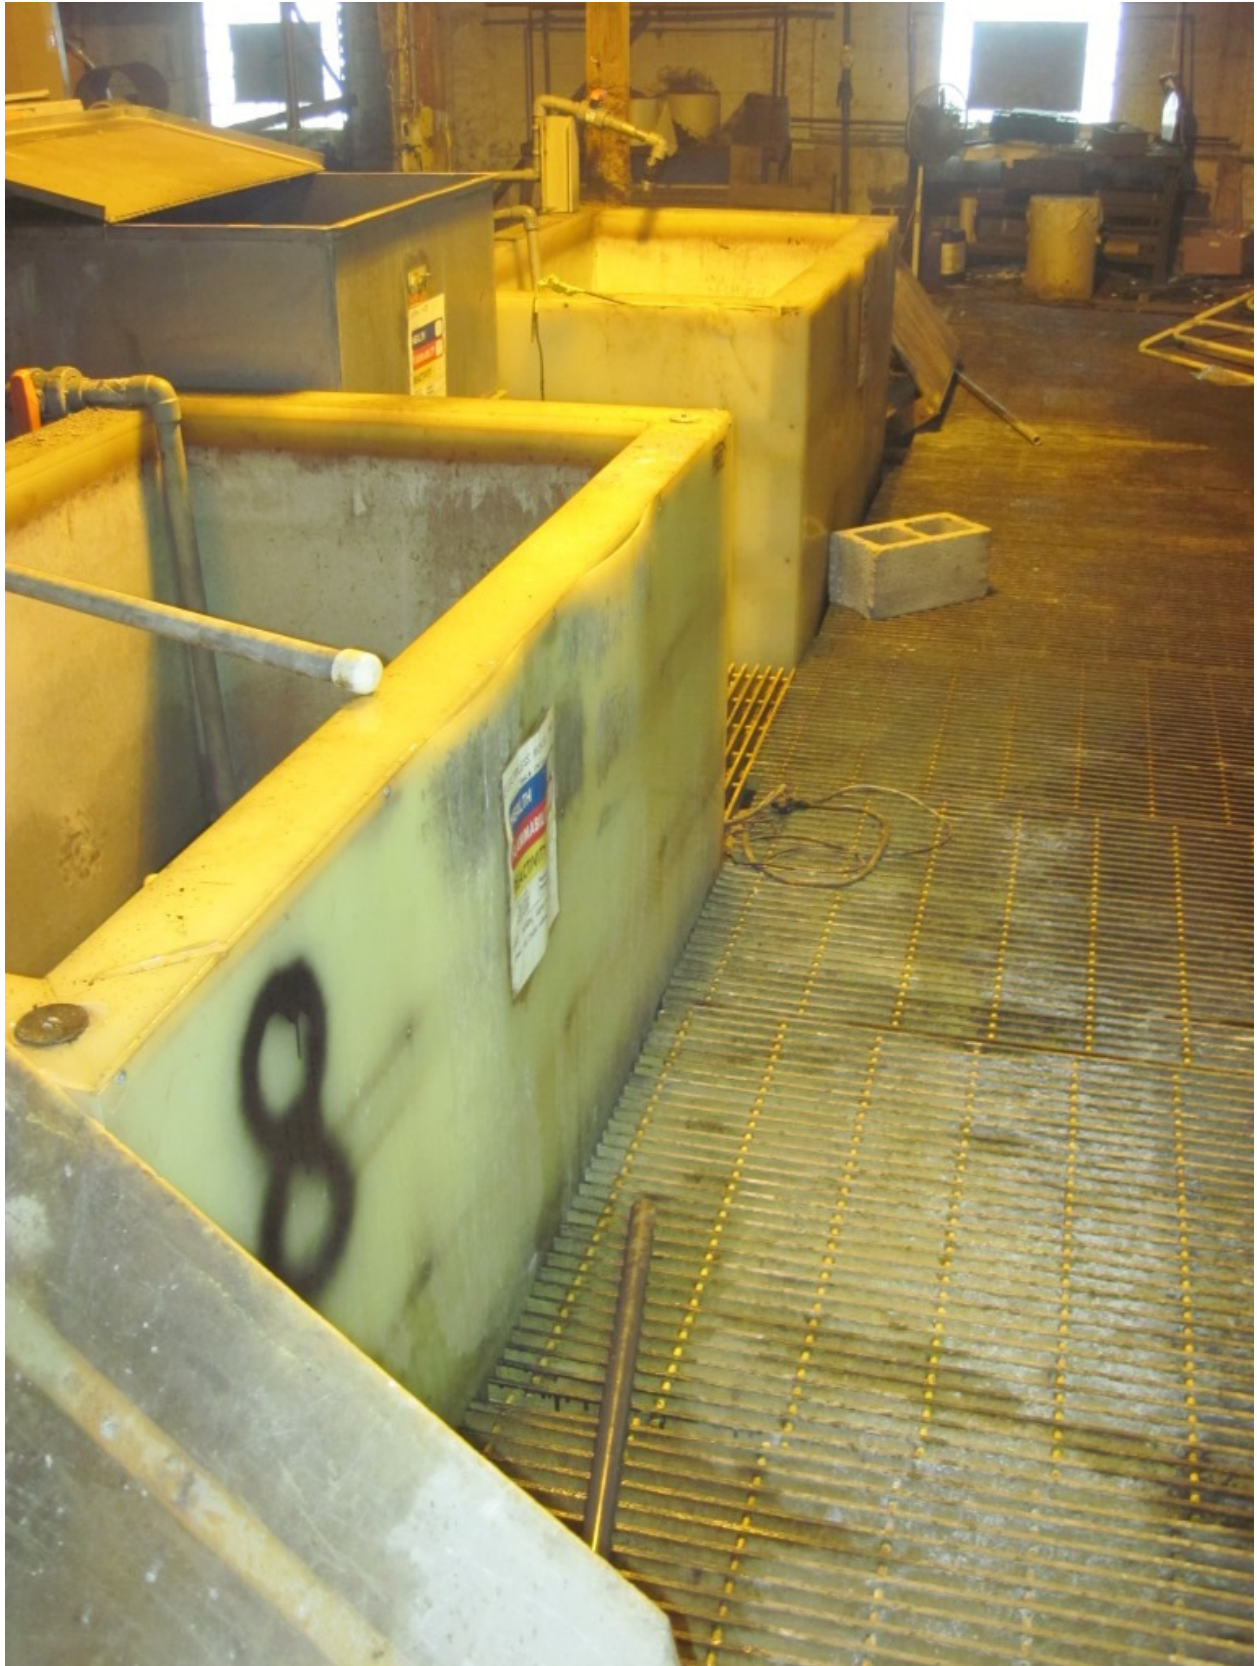
Photo 38: Overview of the electroless nickel plating line area.

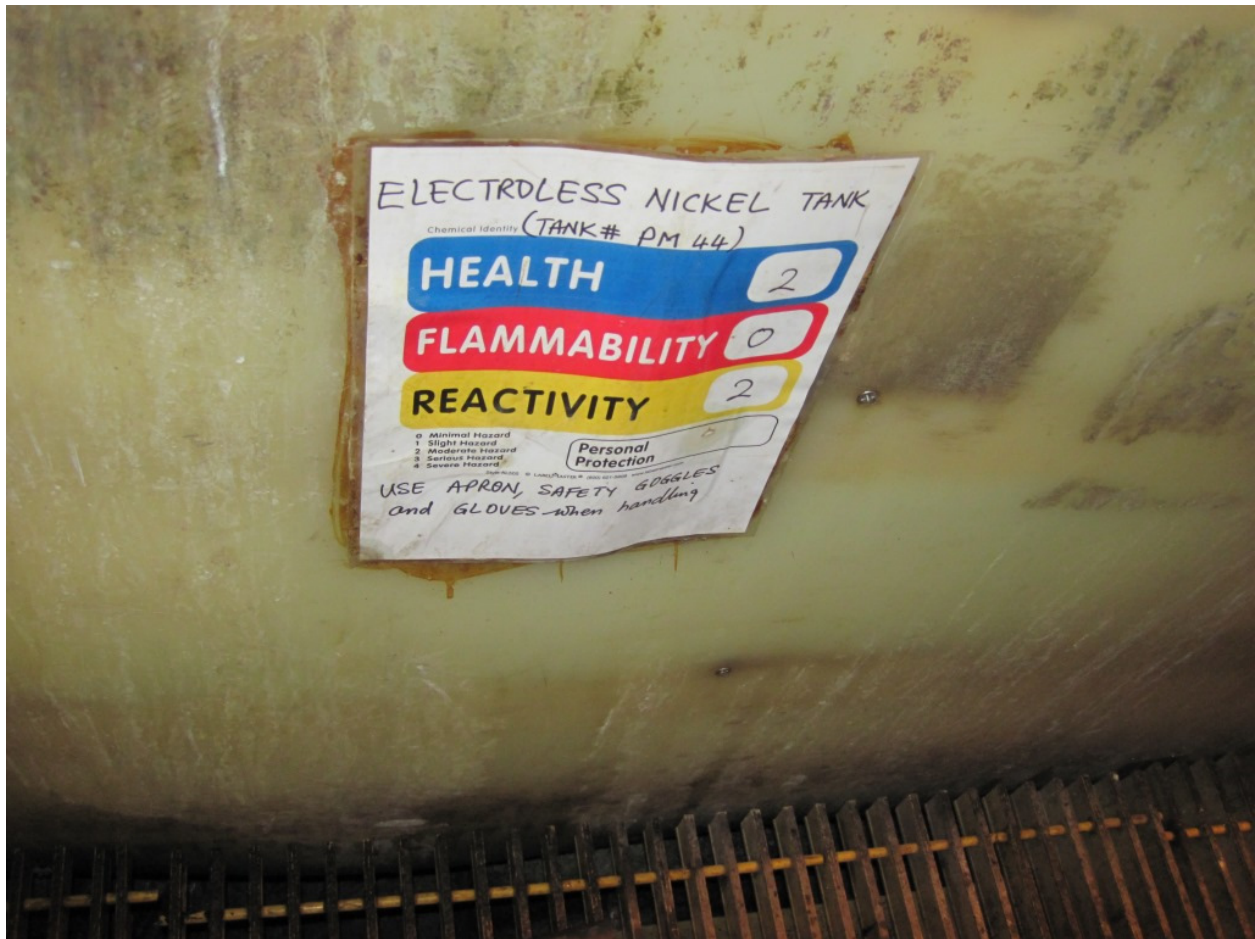
Photo 39: Close-up of a tank with liquid located along the electroless nickel plating line, as seen in Photo #40 below.

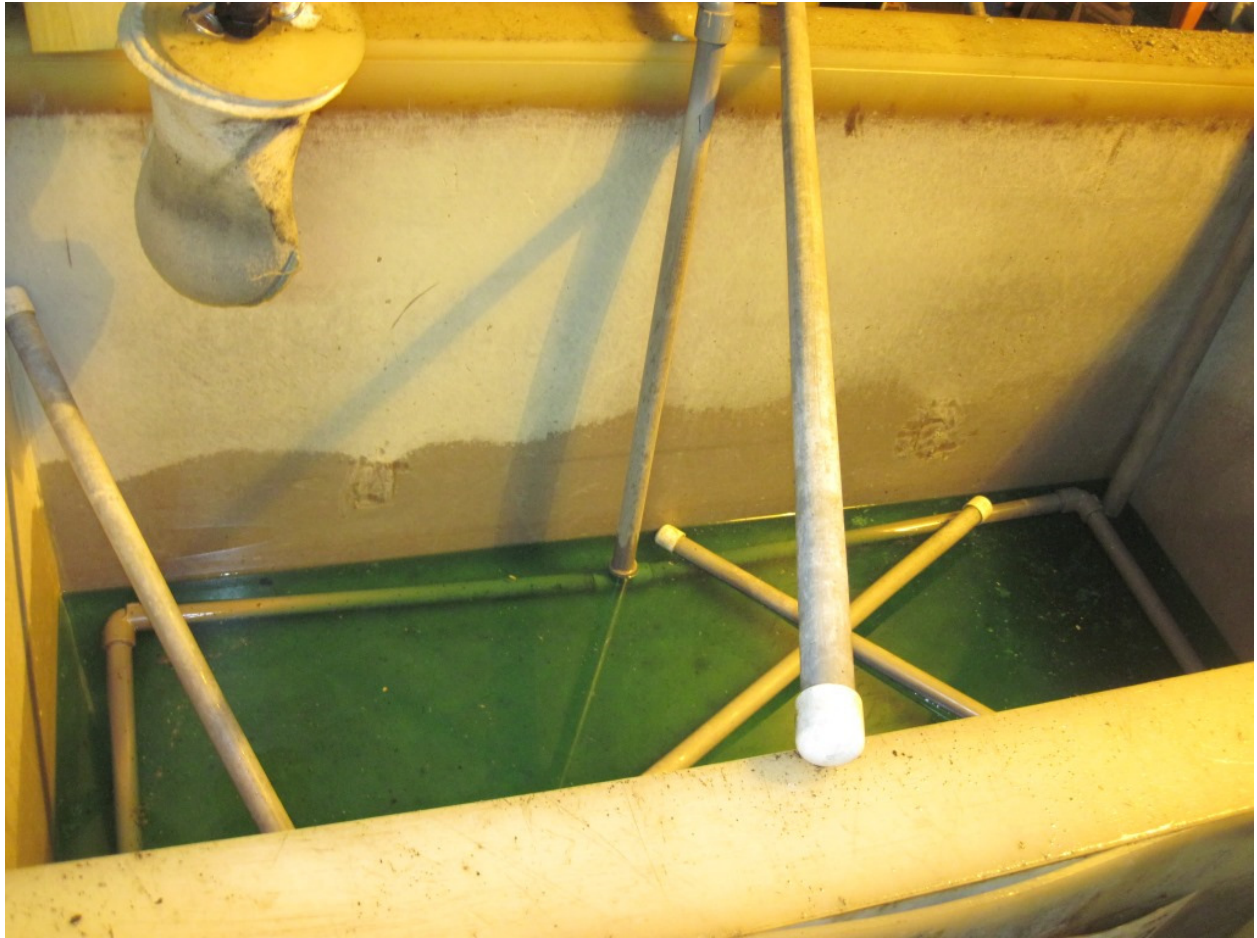
Photo 40: Overview of liquid contained in a tank along the electroless nickel plating line.

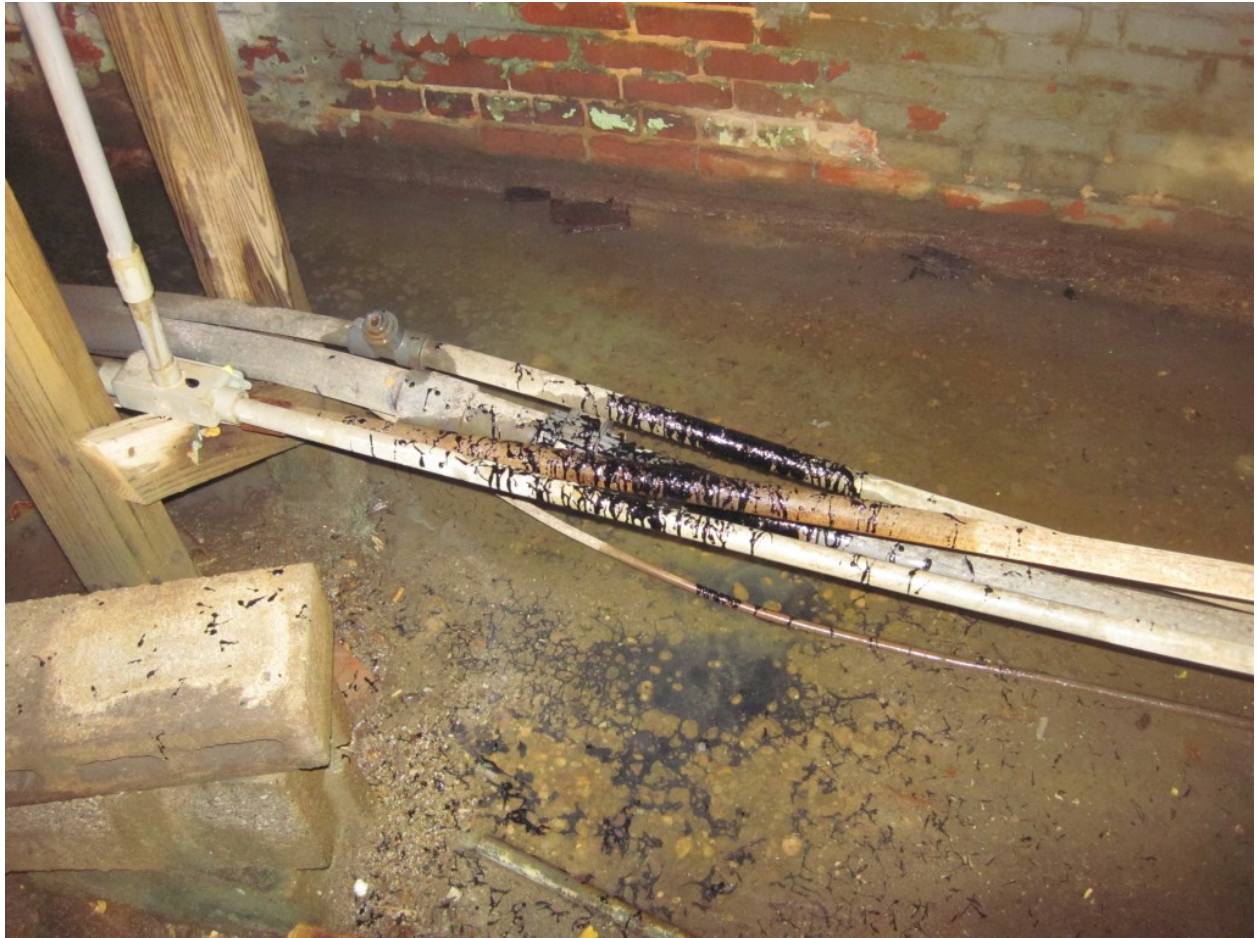
Photo 41: Black masking material accumulated on piping near the electroless plating line.

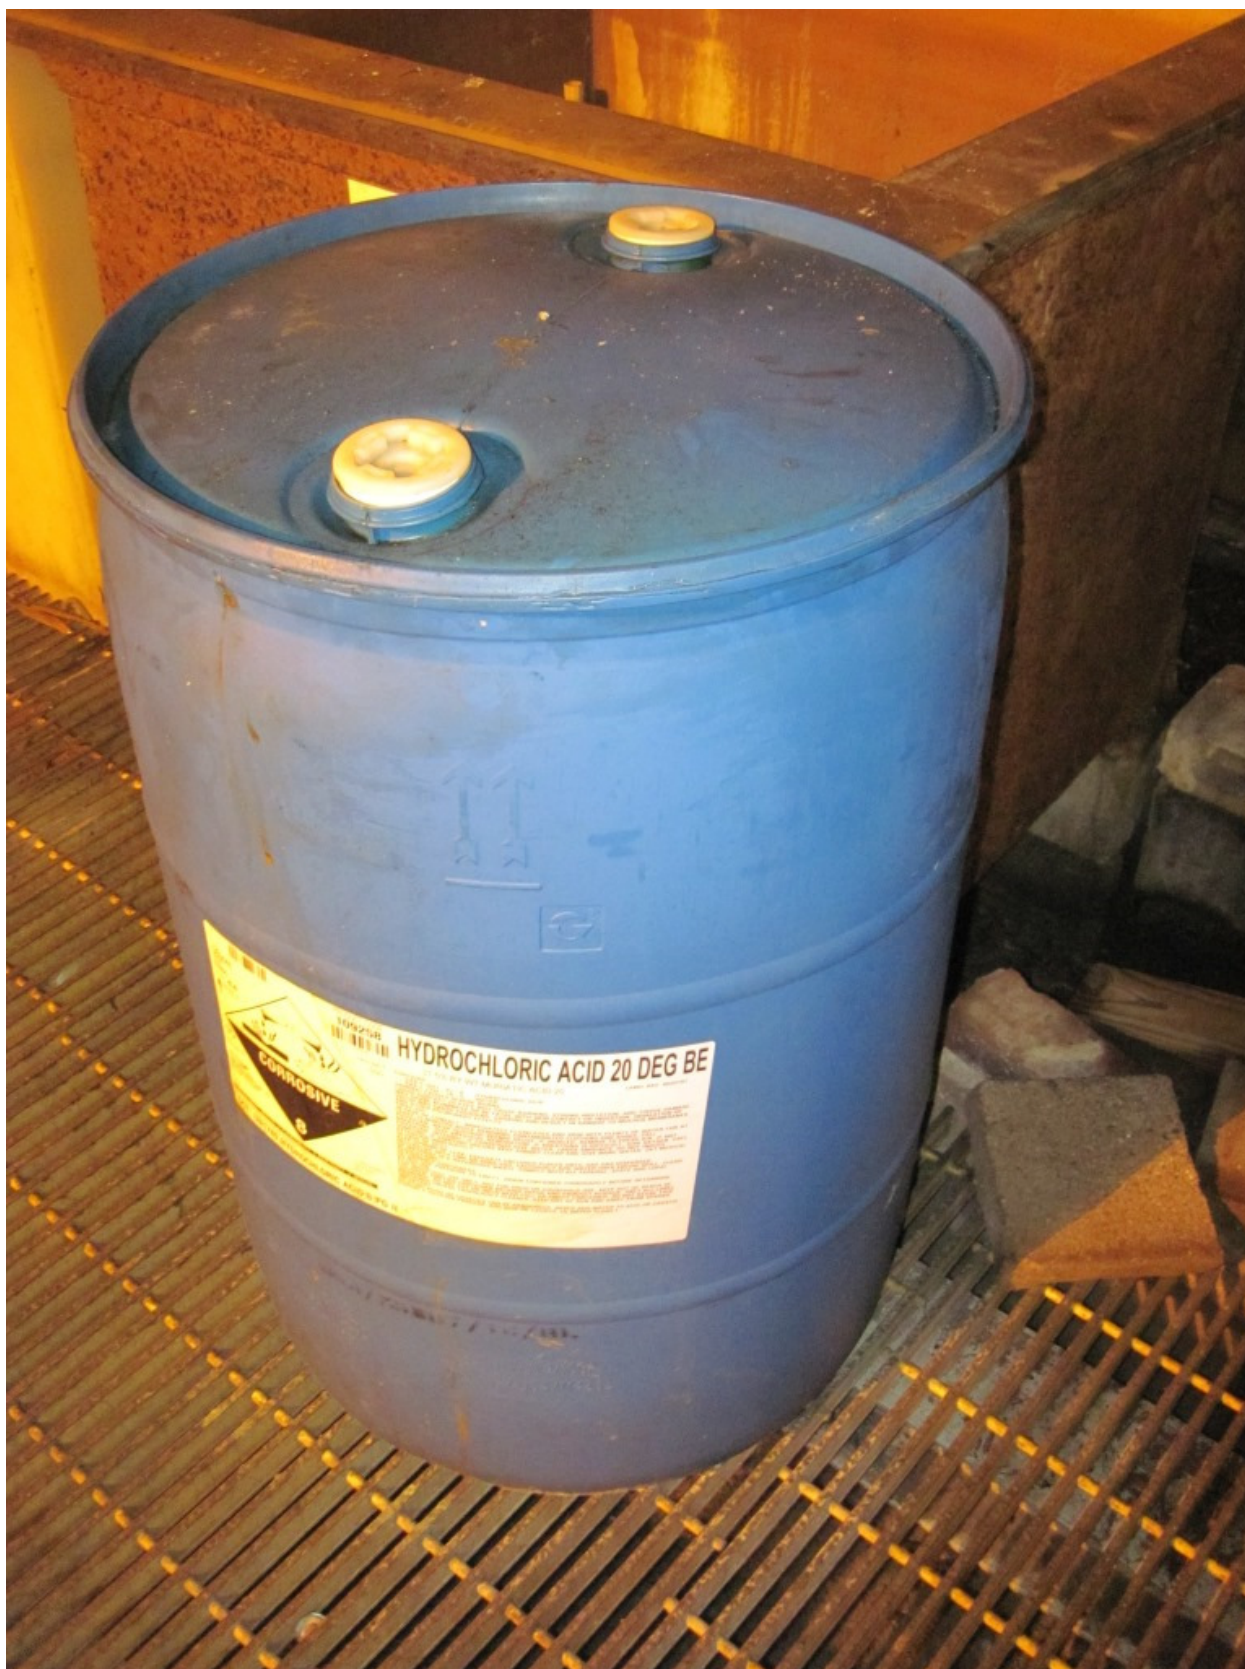
Photo 42: Closed container of tin solution.

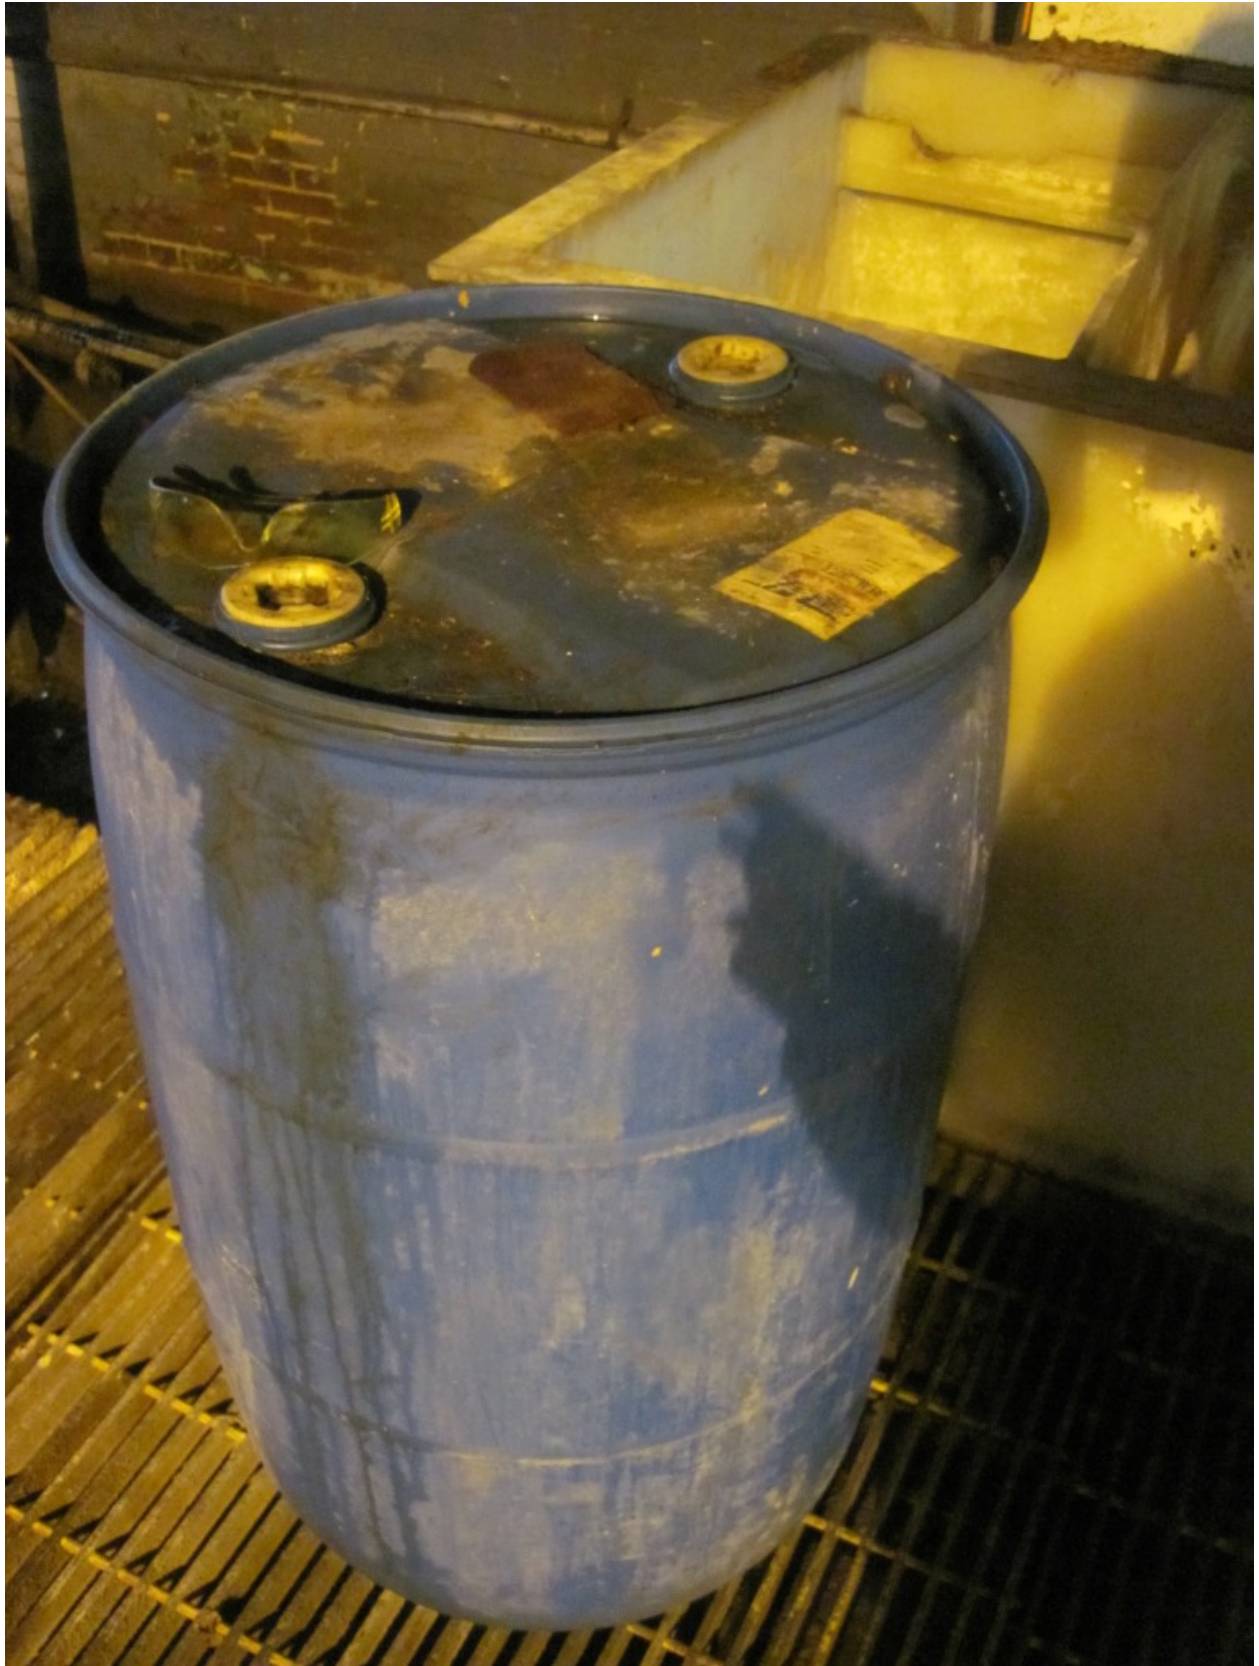
Photo 43: Another closed container of tin solution.

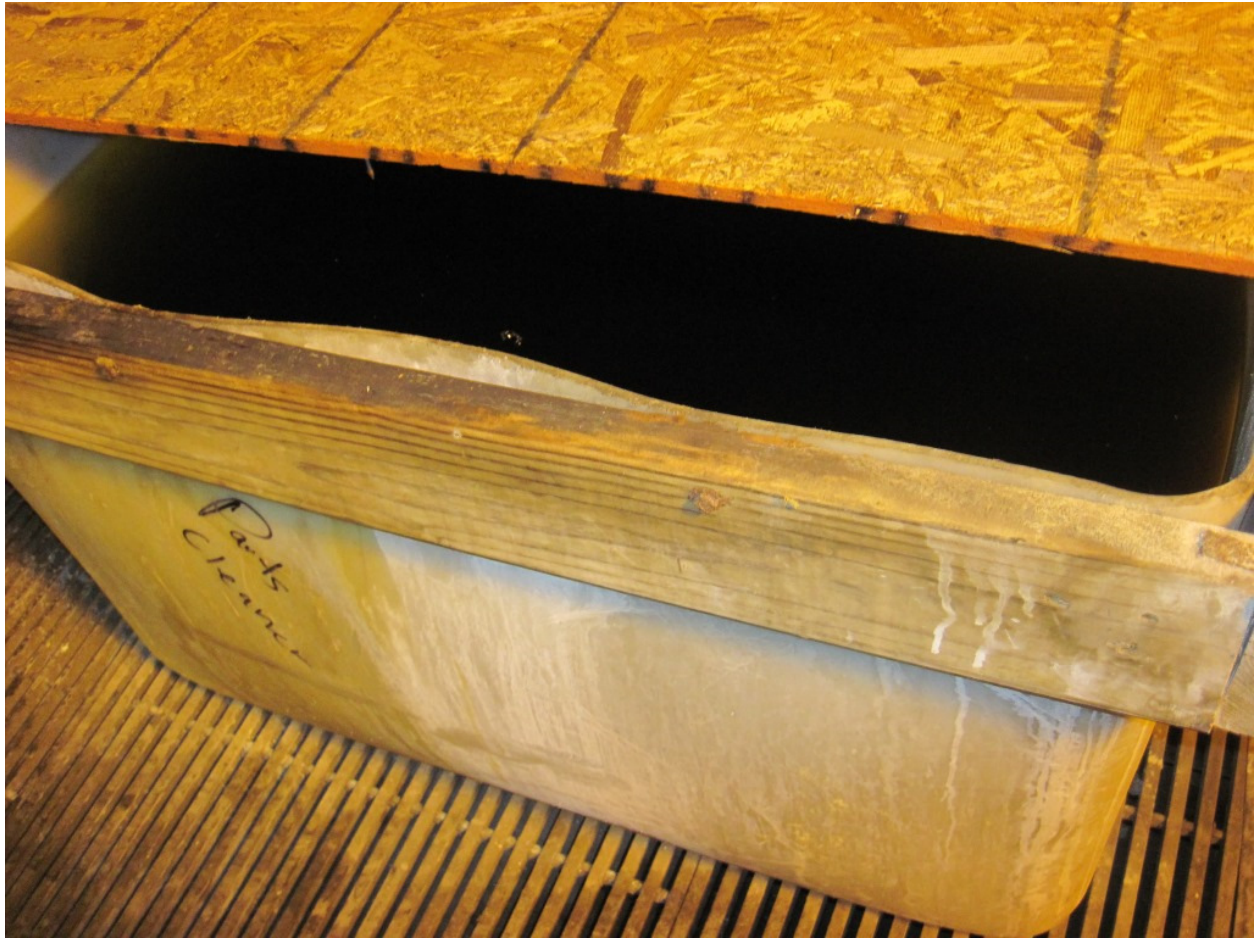
Photo 44: Container of hydrochloric acid and water used to descale and remove rust from parts. The container was covered with a piece of plywood during the inspection.

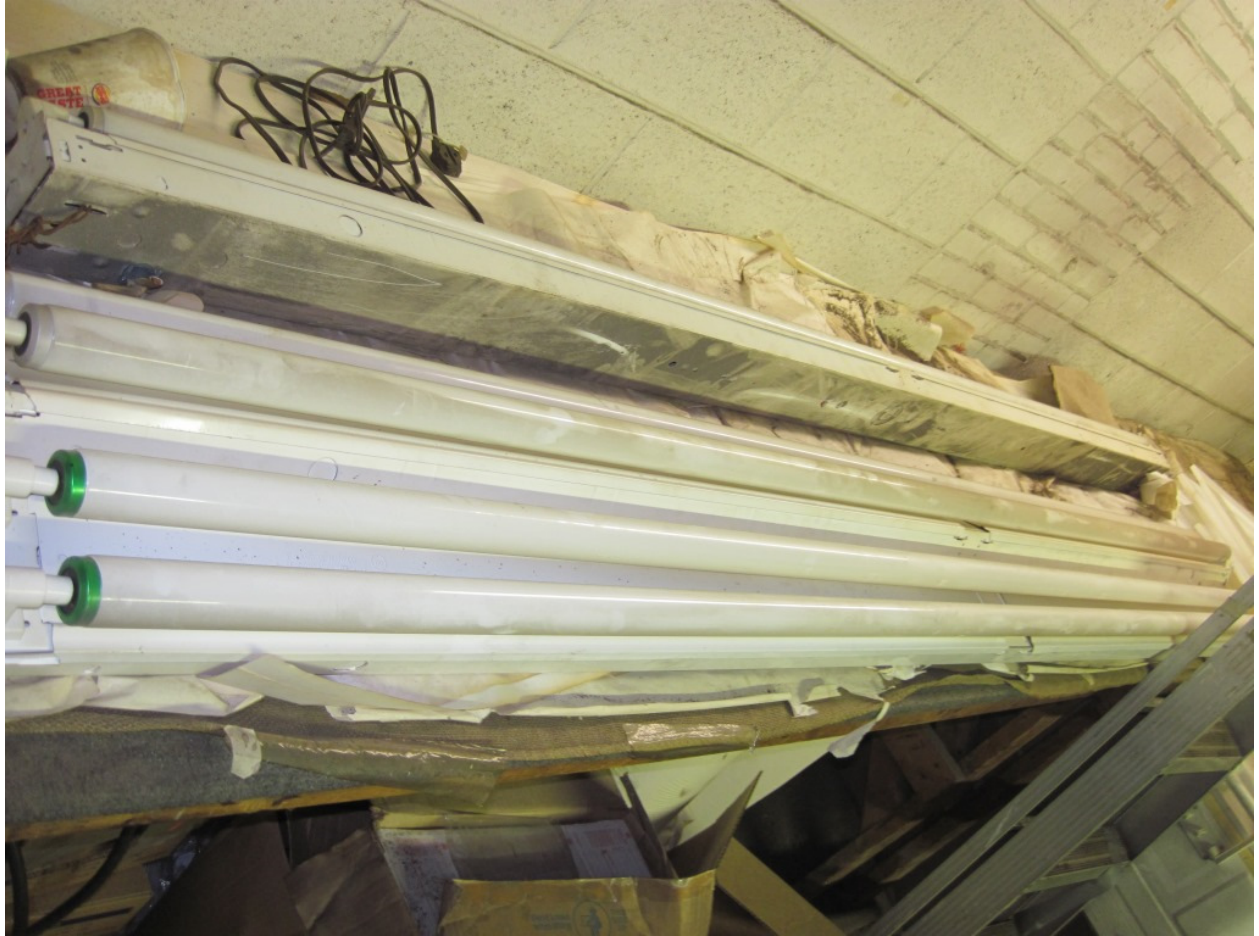
Photo 45: Overview of used universal waste lamps located in the Masking Area.

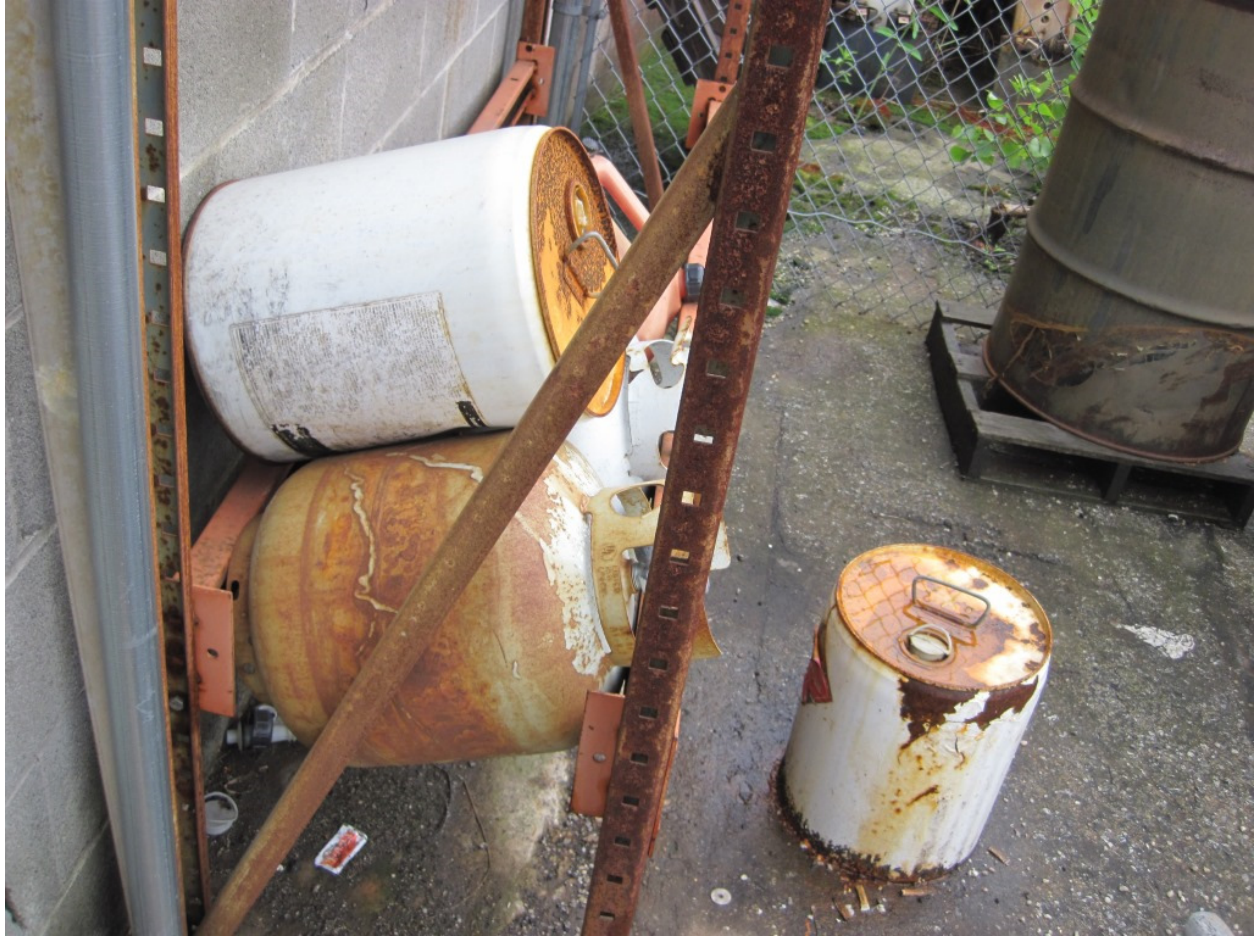
Photo 46: Overview of propane tanks and containers of unknown materials located outside the Facility.

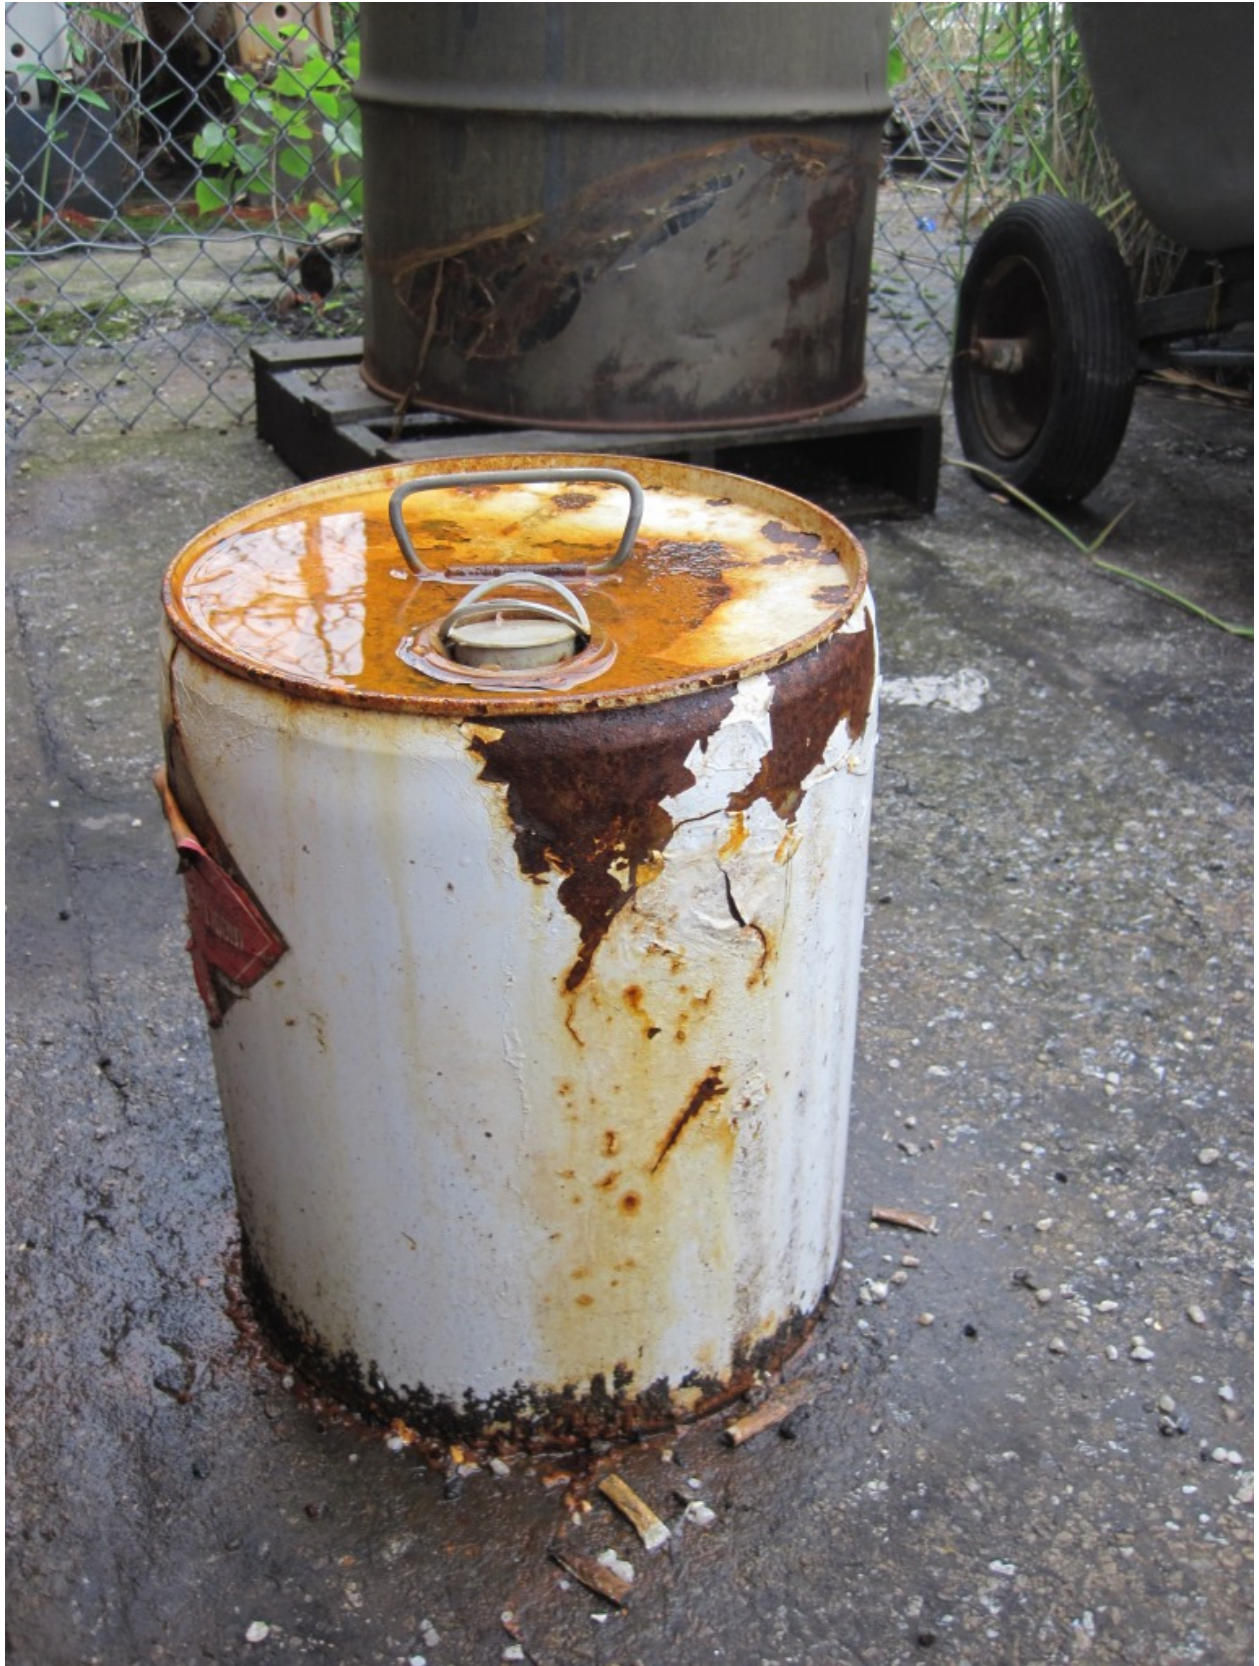
Photo 47: Close-up of a rusted container of unknown material located outside the Facility.

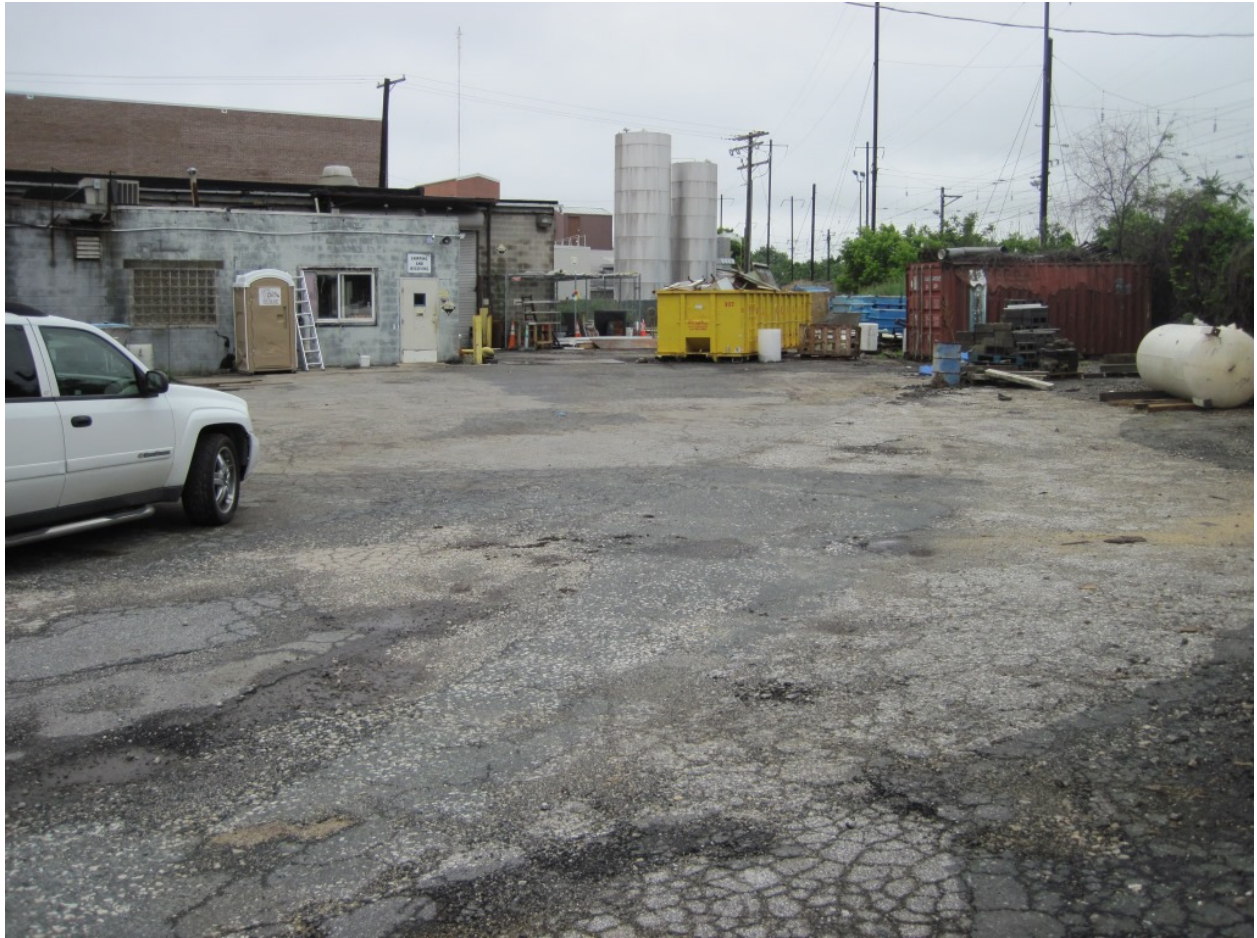
Photo 48: Overview of the rear of the Facility.

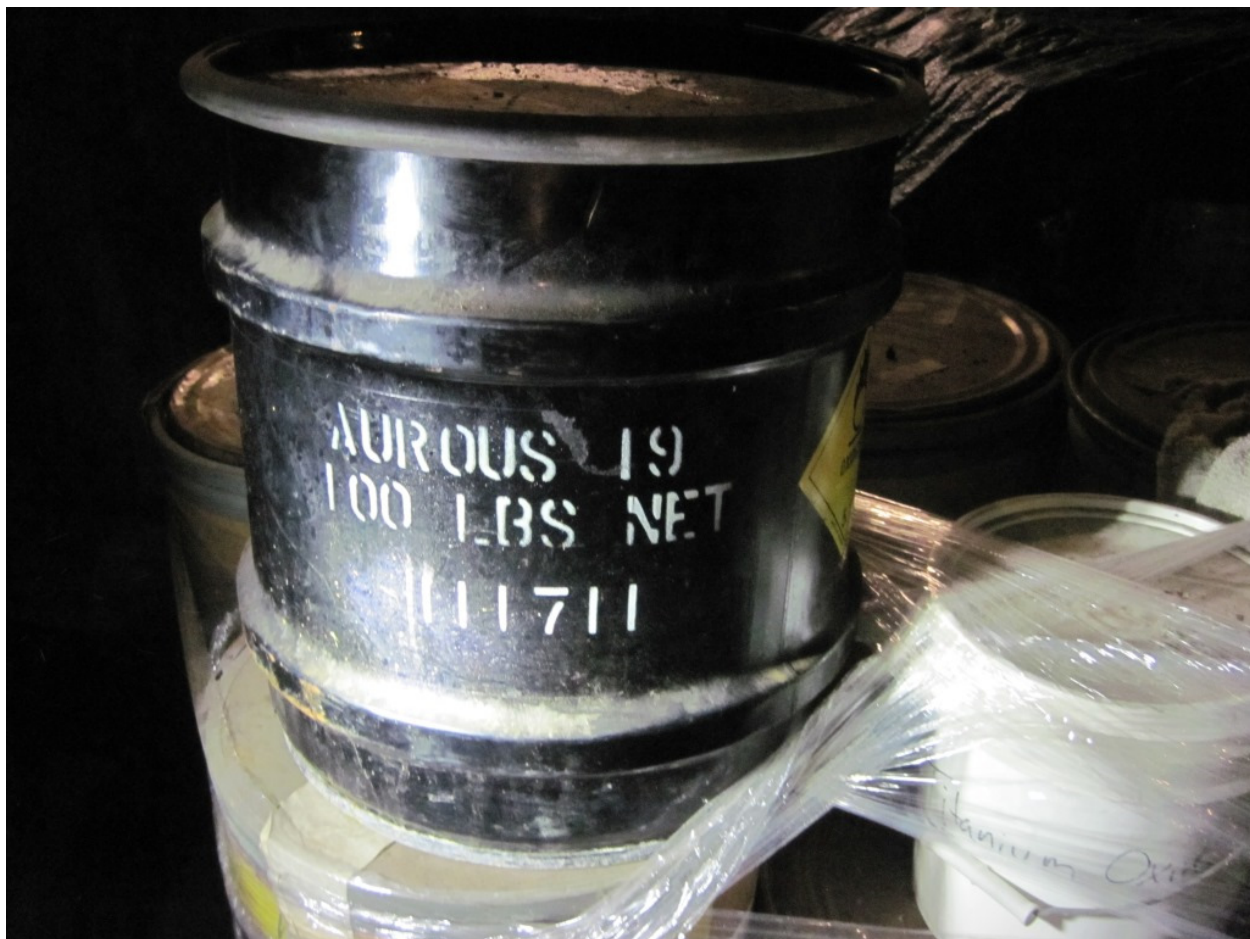
Photo 49: Close-up of dry hexavalent chrome located in the former Automatic Zinc Department.

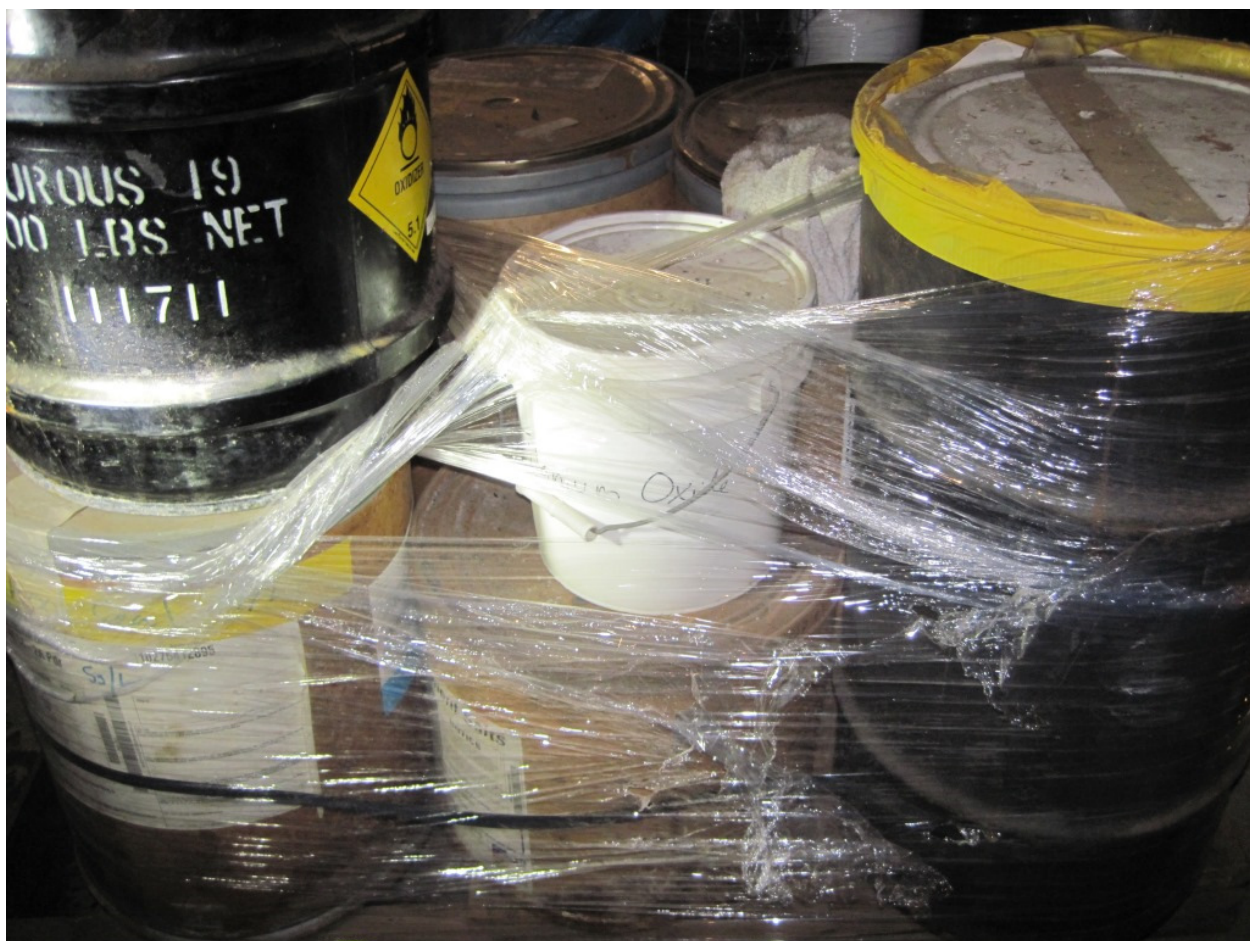
Photo 50: Overview of containers of trivalent chrome located in the former Automatic Zinc Department.
